The Lamoille Valley Rail Trail

Brief History of the Lamoille Valley Rail Line

Lamoille Valley Rail-Trail Facts

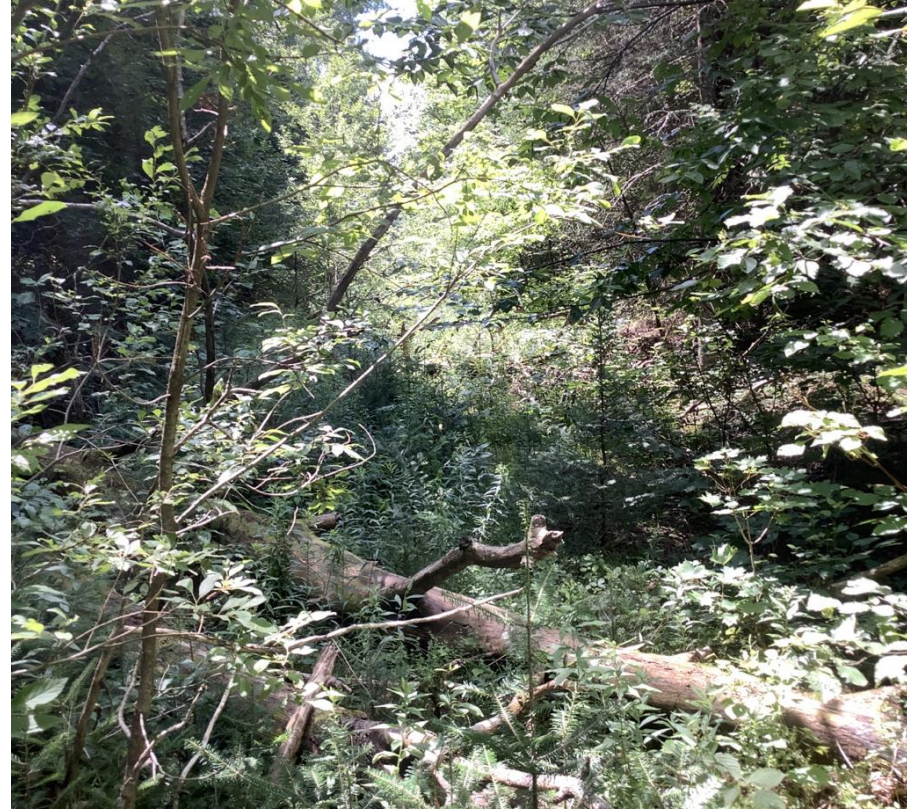
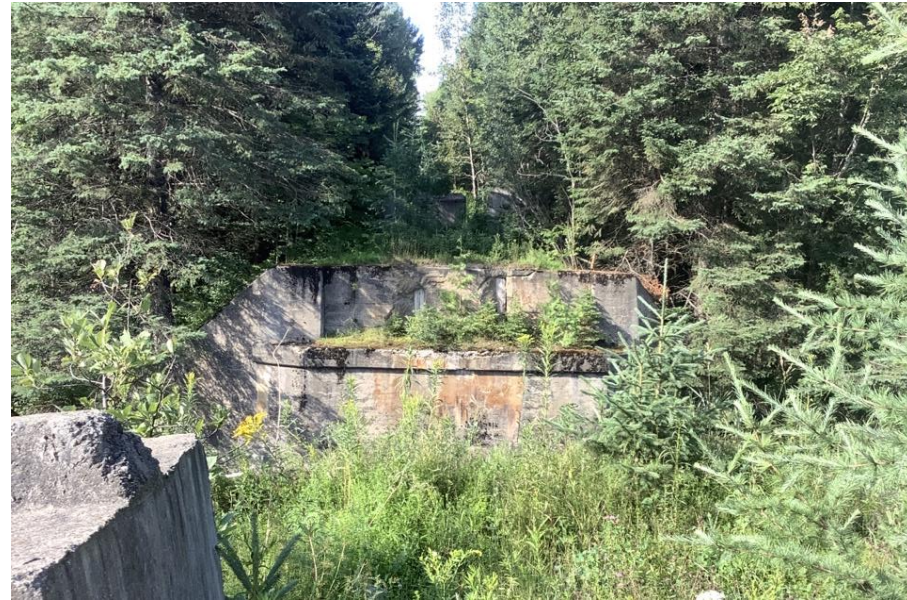
Survey

- Traditional survey would have taken a year
- Too dense of vegetation for drone or lidar
- Tablets loaded with GIS web maps to work offline with R1 GPS Receivers
- Collector application utilized to photograph and note every feature as well as natural resources
- Traditional survey used for 11 bridges
- Stream surveys completed utilizing rod and laser working off a theoretical datum

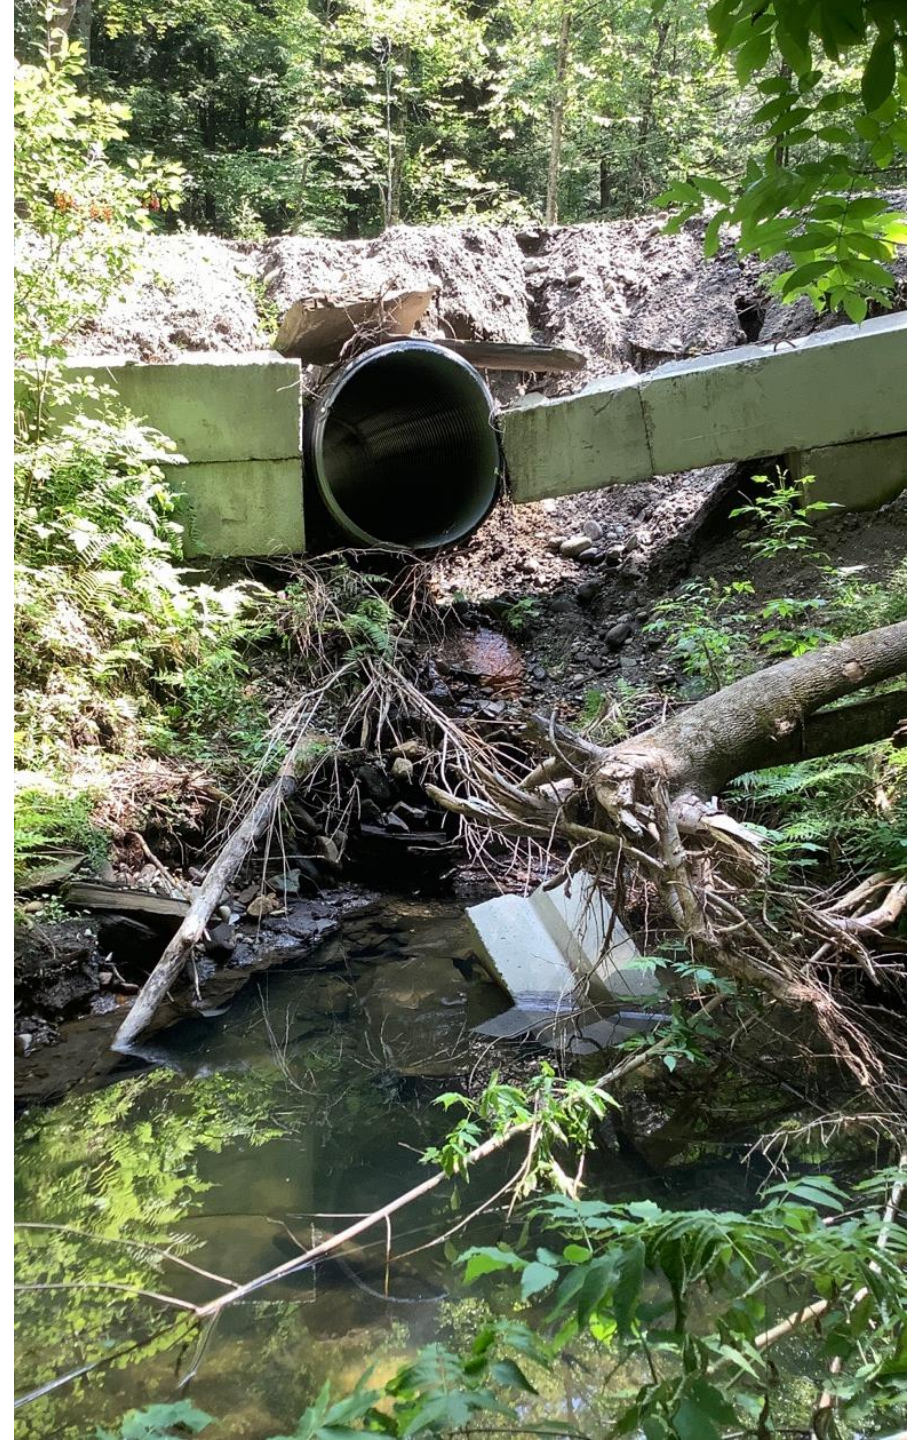
Culverts

- **280 culverts**
- Major scour pools were a common trend as well as built up vegetation and debris
- Some have 1 foot of cover, others 30 feet
- Every existing stone box culvert required historical review before determining the appropriate construction action
- Modeled all perennial streams and larger
- Re-aligned culverts to better match stream channels horizontally and vertically

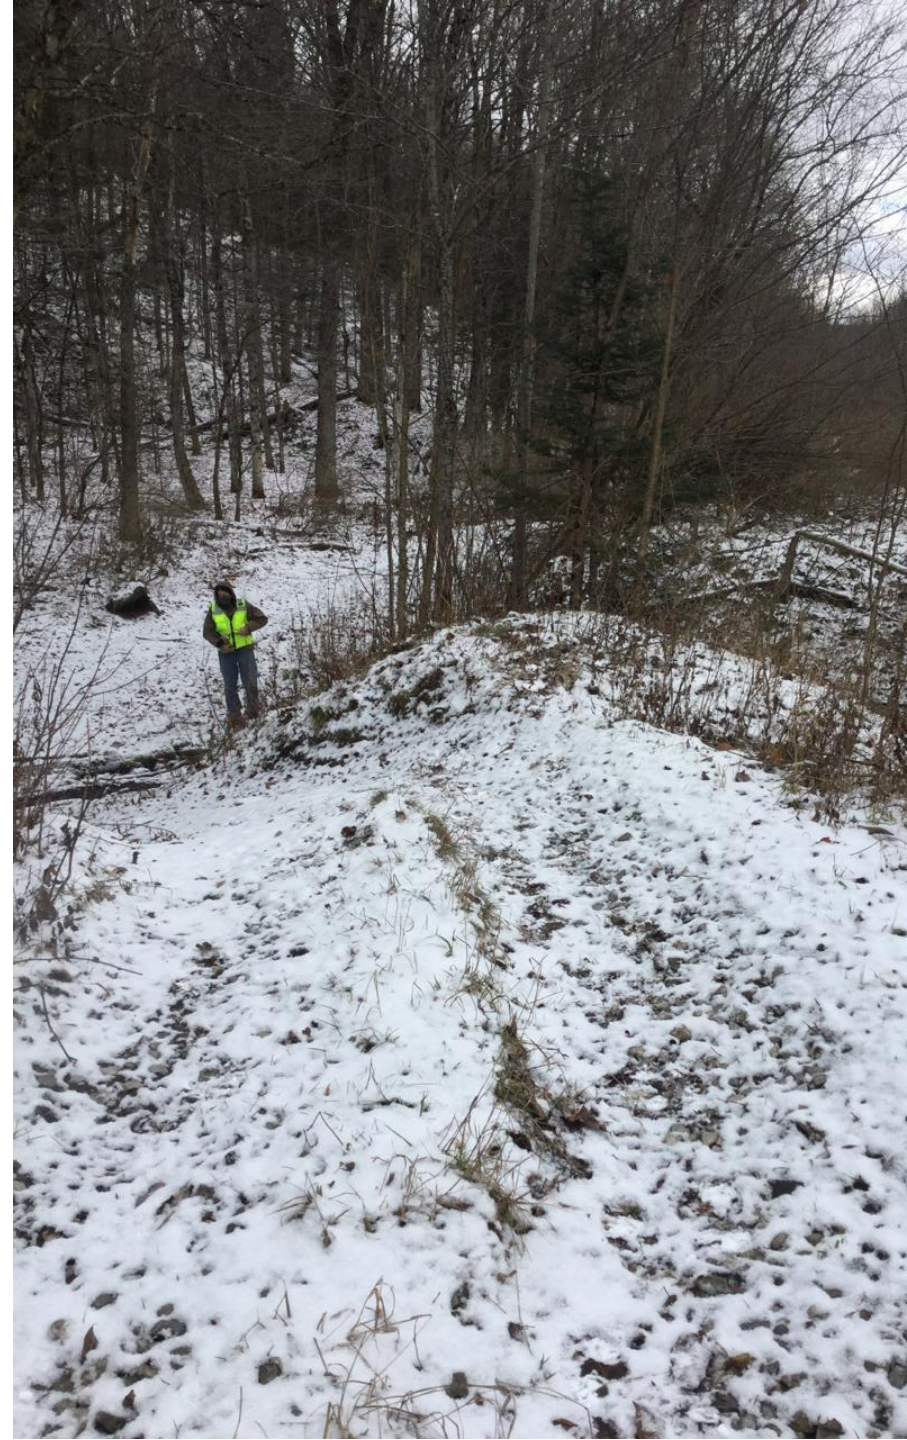
Washouts

- **45 washouts**
- Ponding in trail resulted in raising the trail
- Slope failure was repaired, and erosion protection was applied
- At a handful of locations, the entire trail embankment was washed away and required re-building
- Locations where the existing embankment was not able to support the full trail width, profile lowering was utilized to achieve the desired width

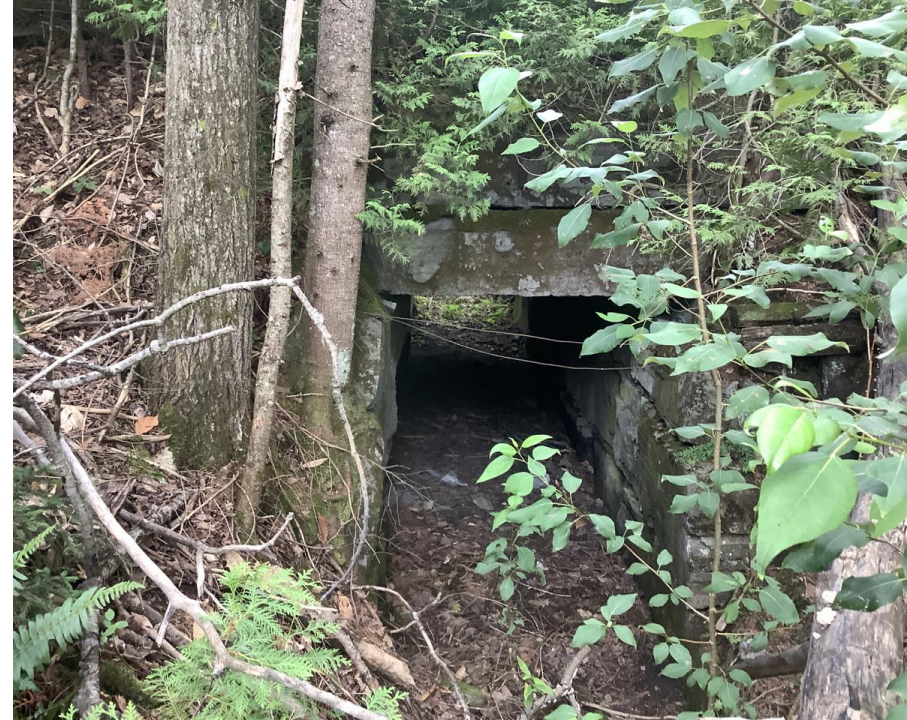
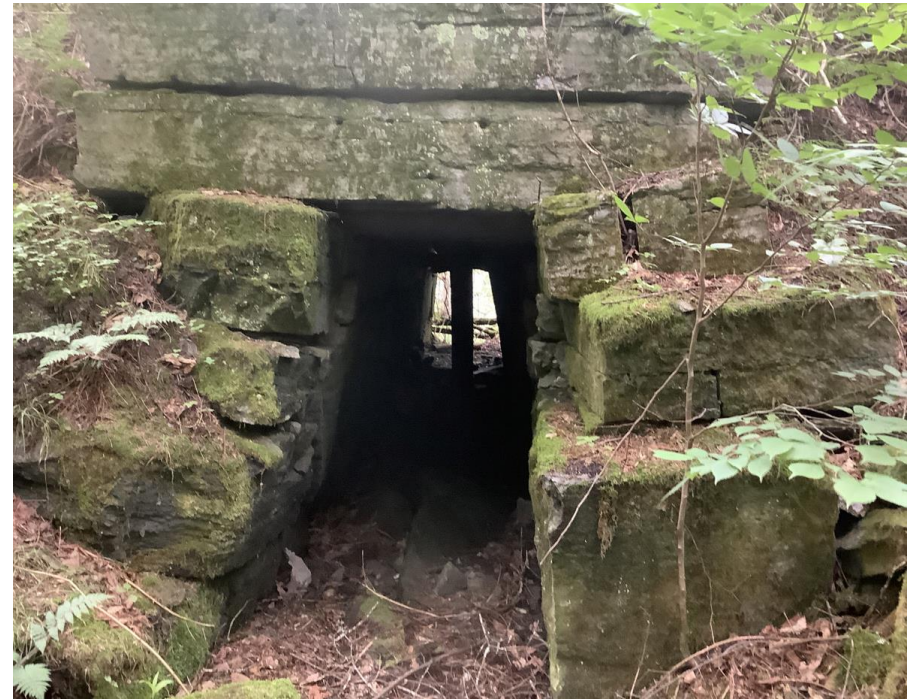
Cattlepasses

- **18 cattlepasses**
- Shall it be demoed?
 - Does it meet historic preservation criteria?
 - Is there a function to the adjacent land owners?
 - Is it structurally stable?
 - Can the necessary safety measures be installed?
 - Does it add to the LVRT atmosphere?

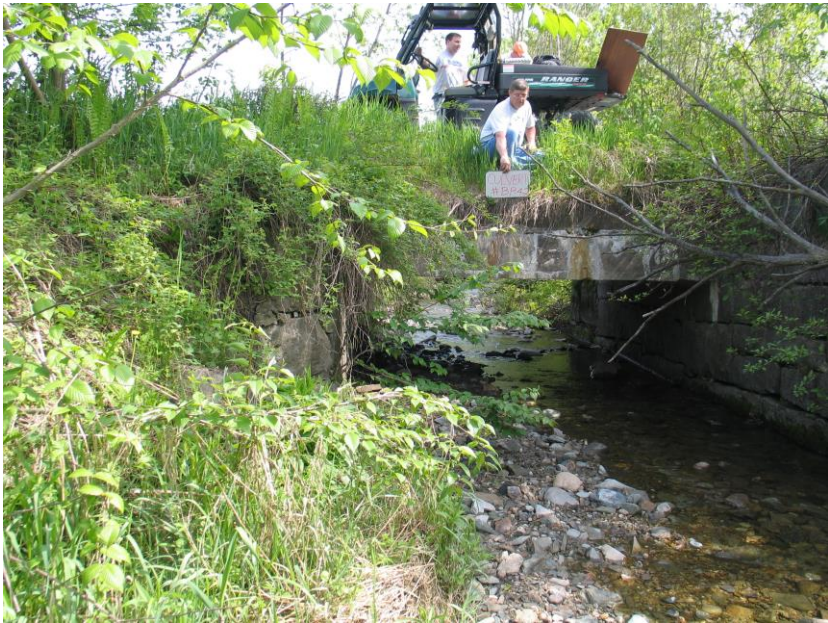
Re-Assessment of Inventory

- Original assessment completed by VAST in 2009
- Additional inspection by VHB
- Current scope called for assessment of 34 Bridges

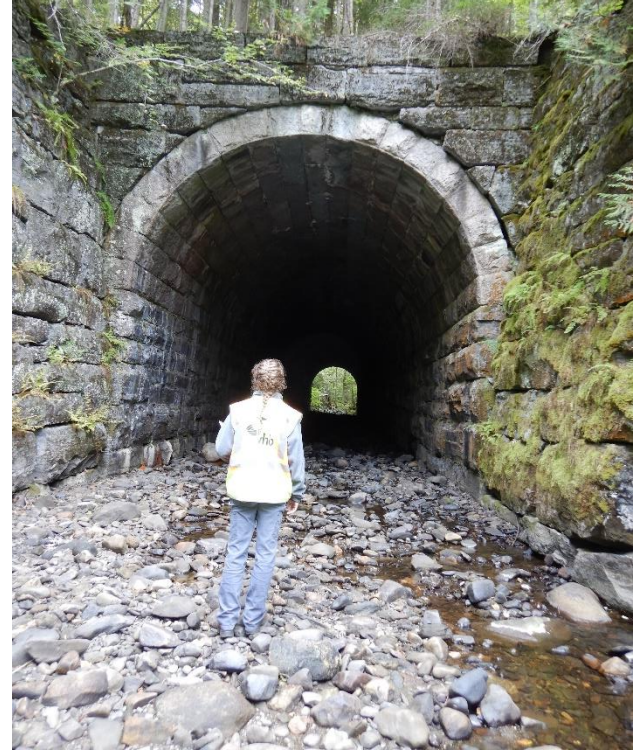
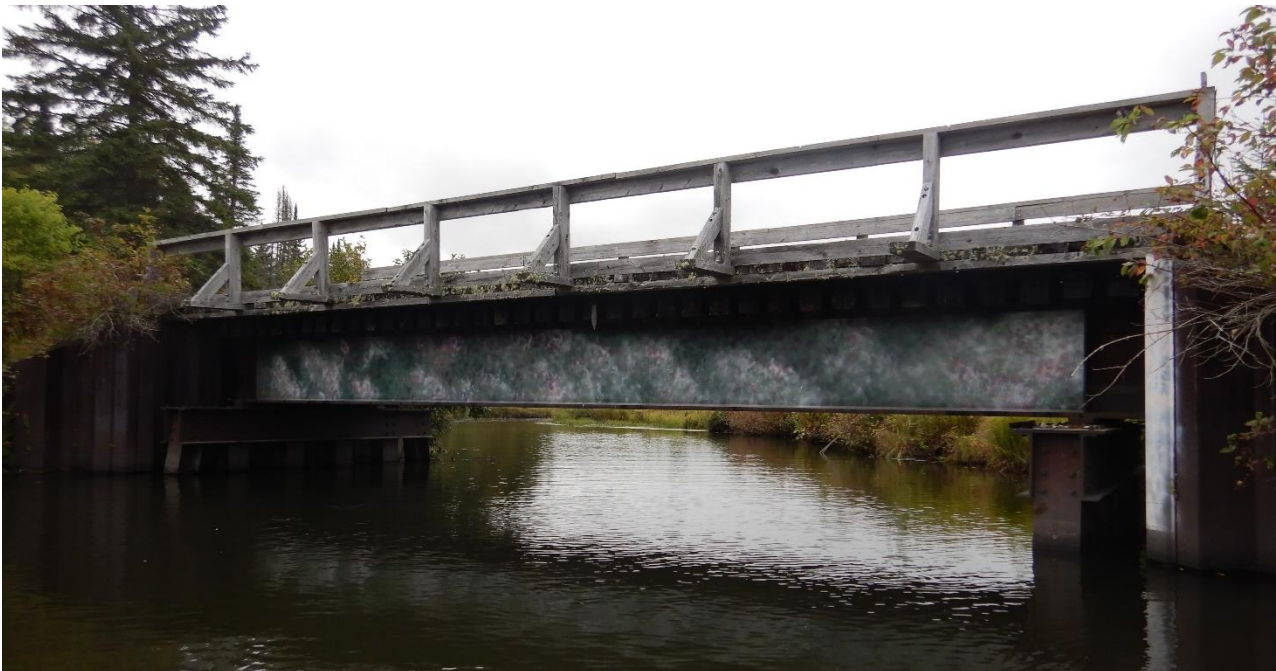
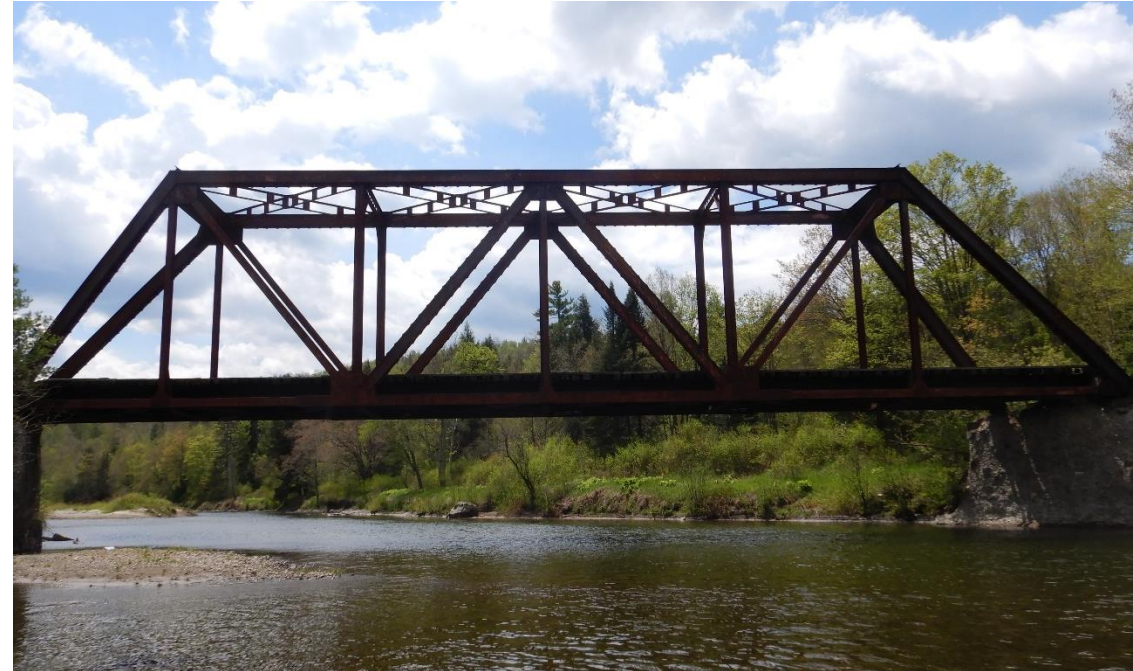
Types of Bridges

- Steel stingers with timber decks
- Historic trusses
- Concrete slab/rail top
- Stone arches

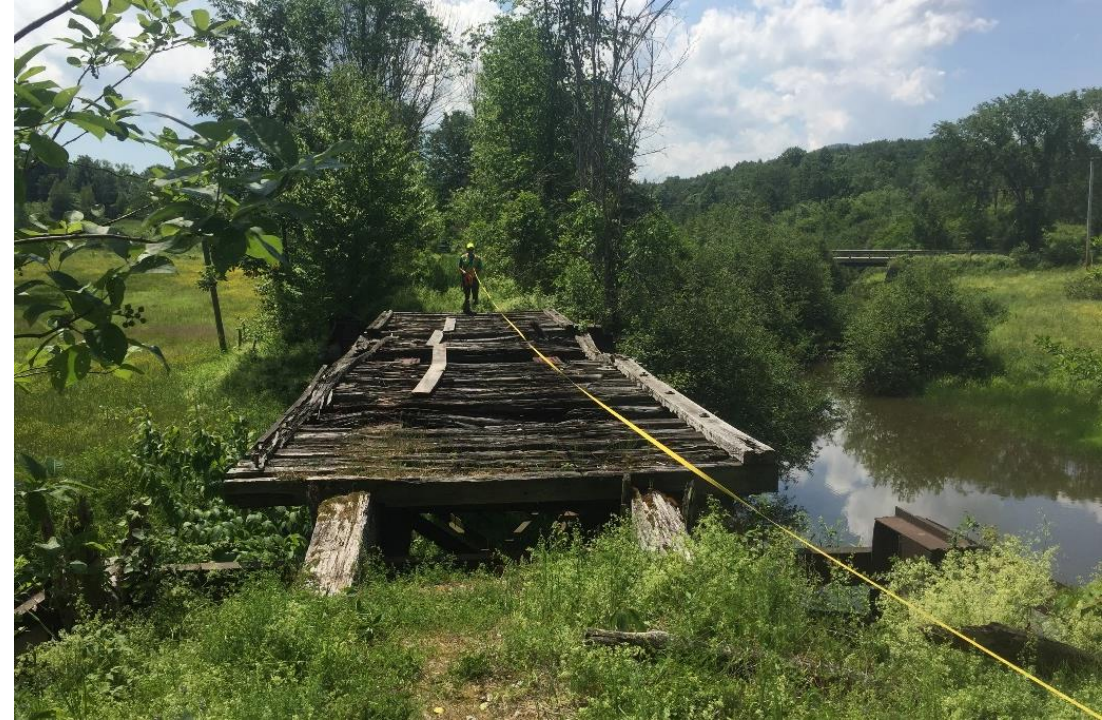
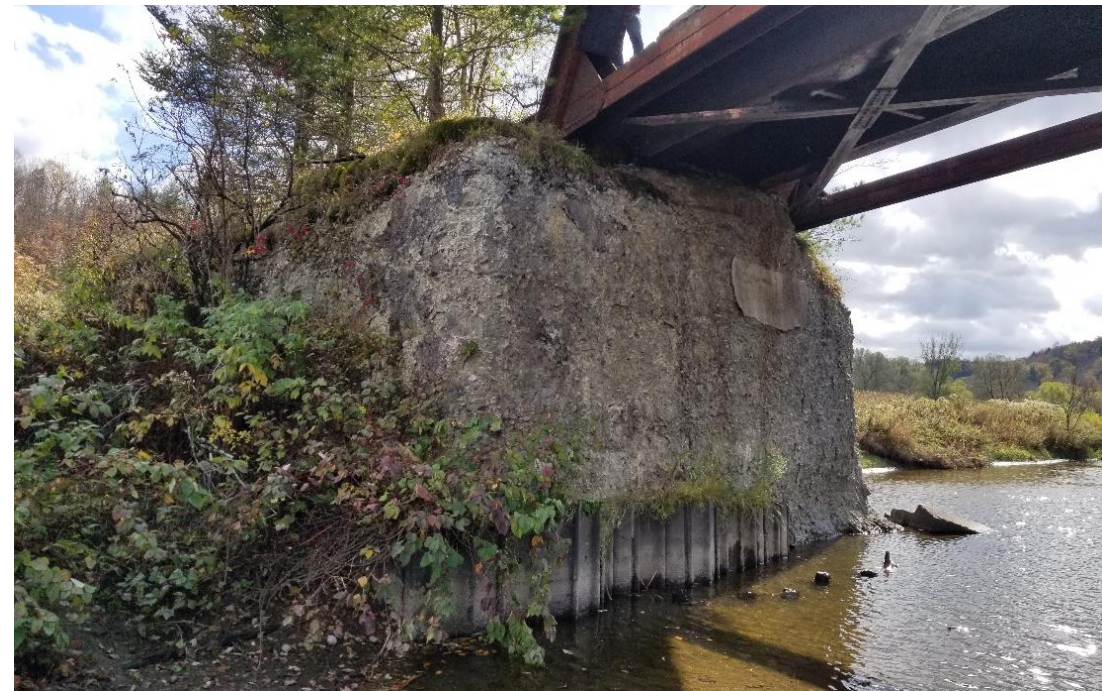
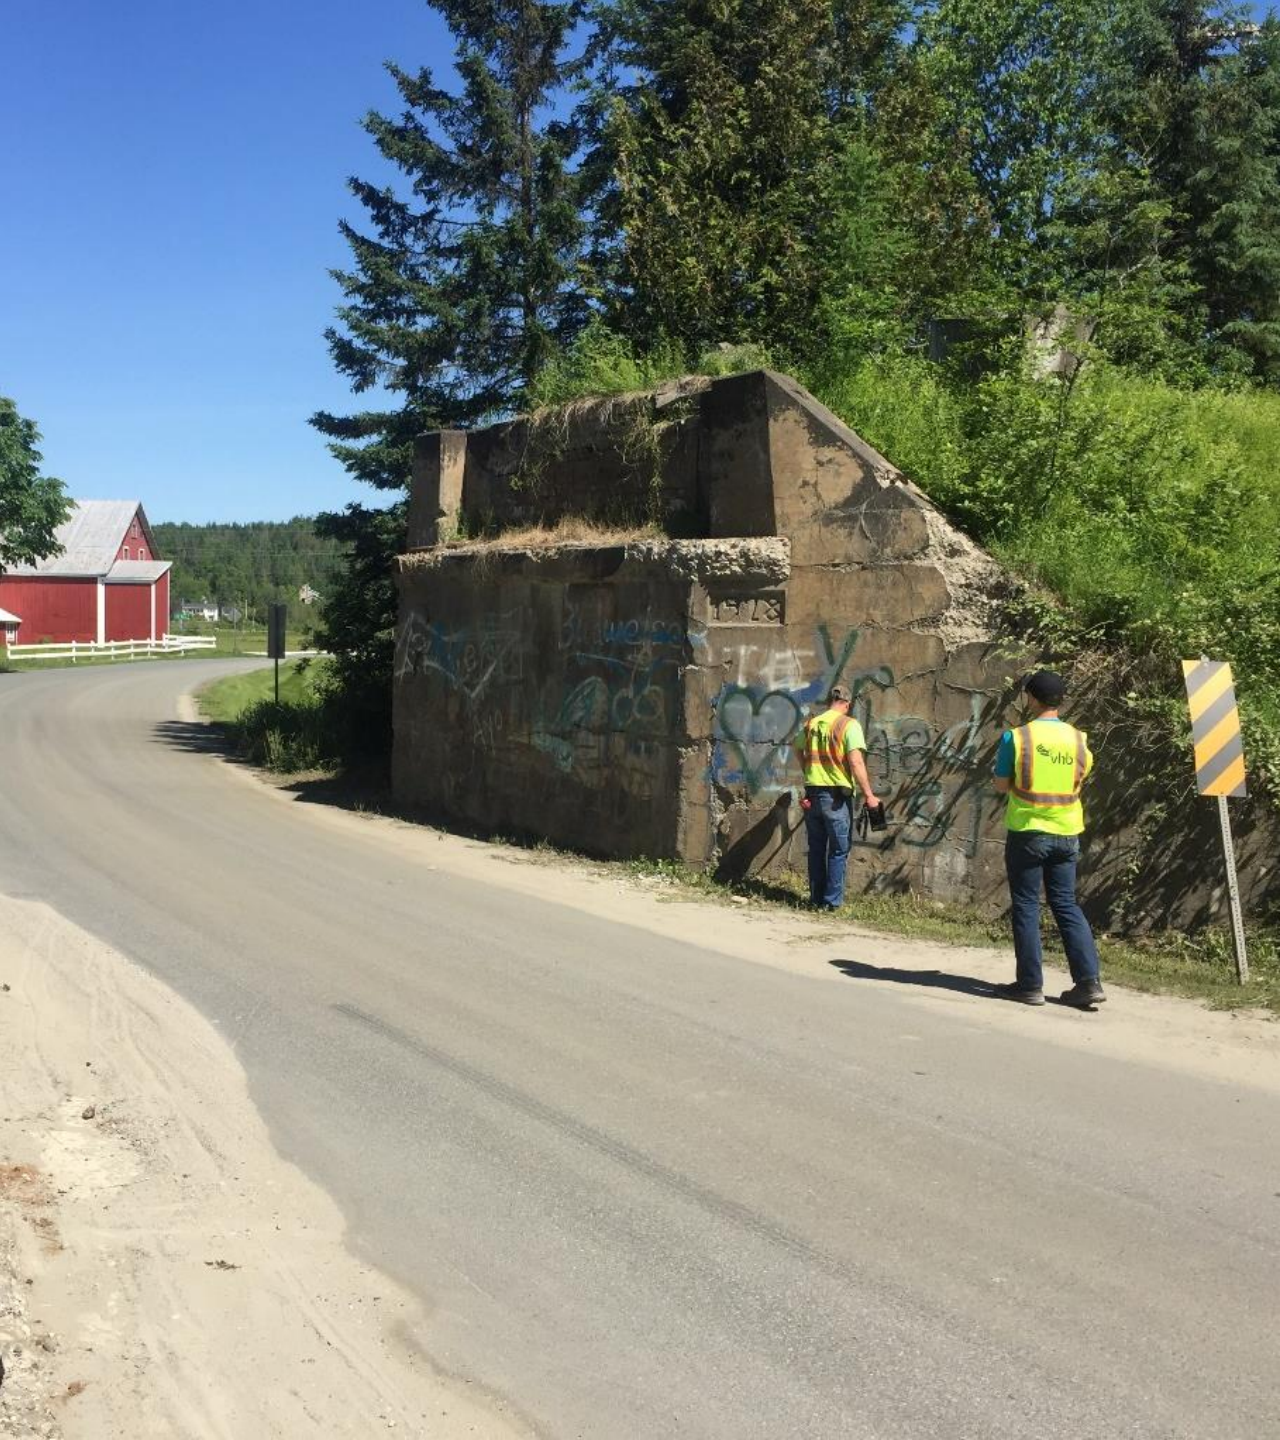
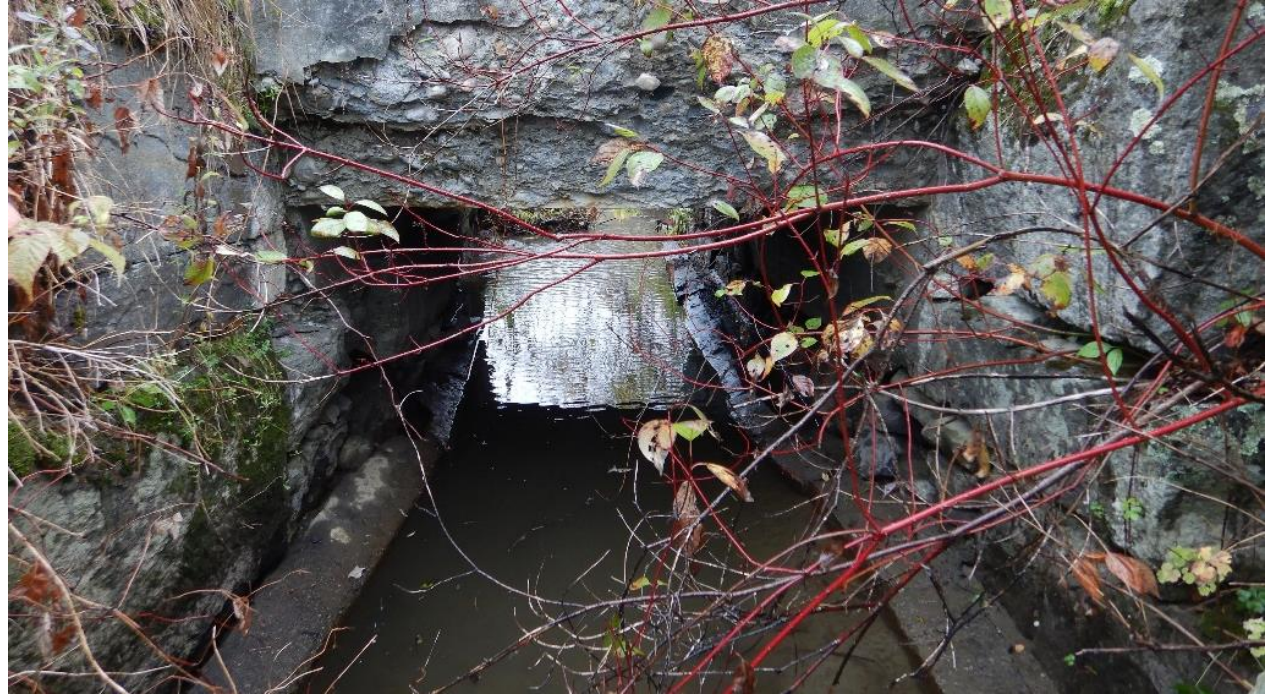
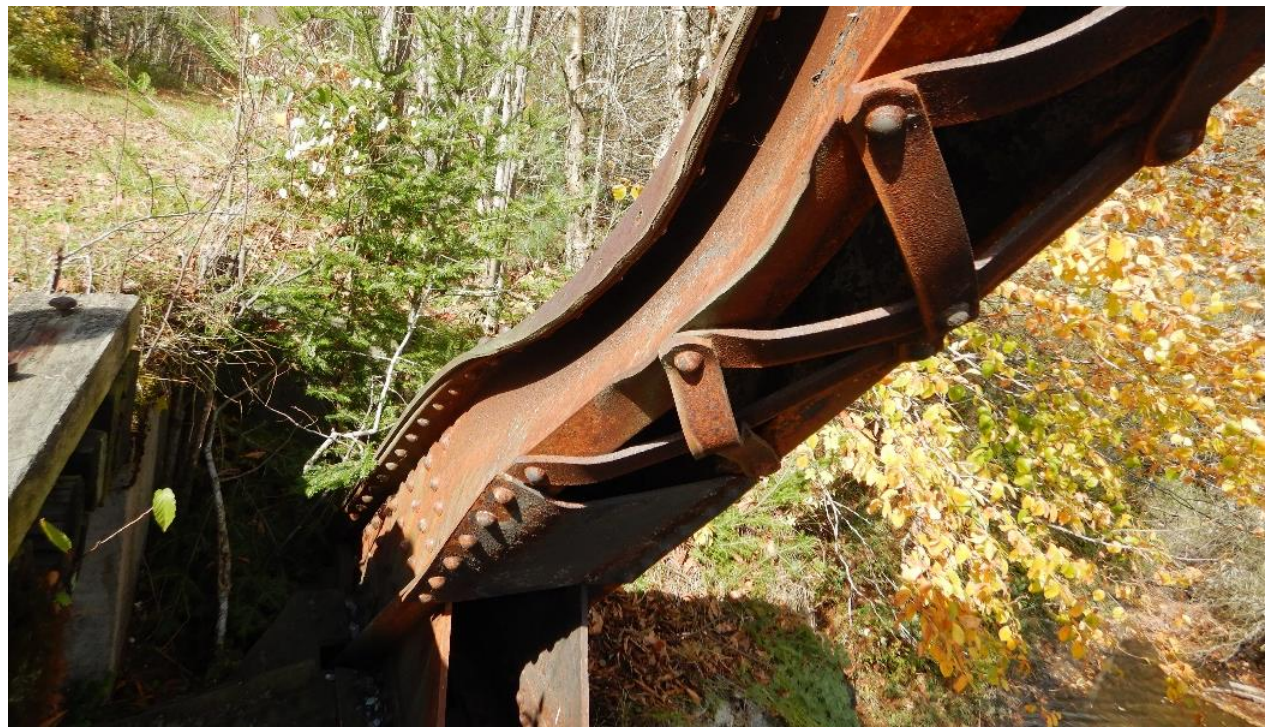
Inspection Findings

- Deteriorated decks
 - Limited or no railings
- Substructures in poor condition
- Removed superstructures
- Undersized structures
- Damaged superstructures

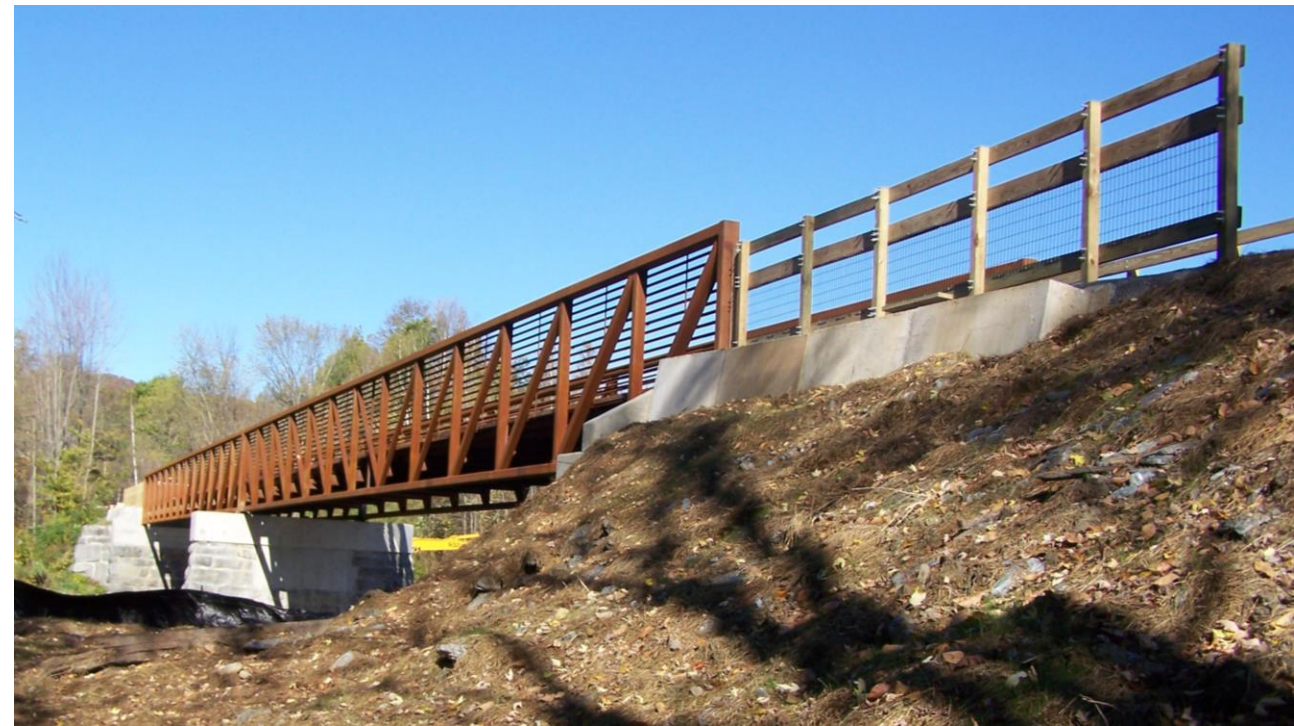
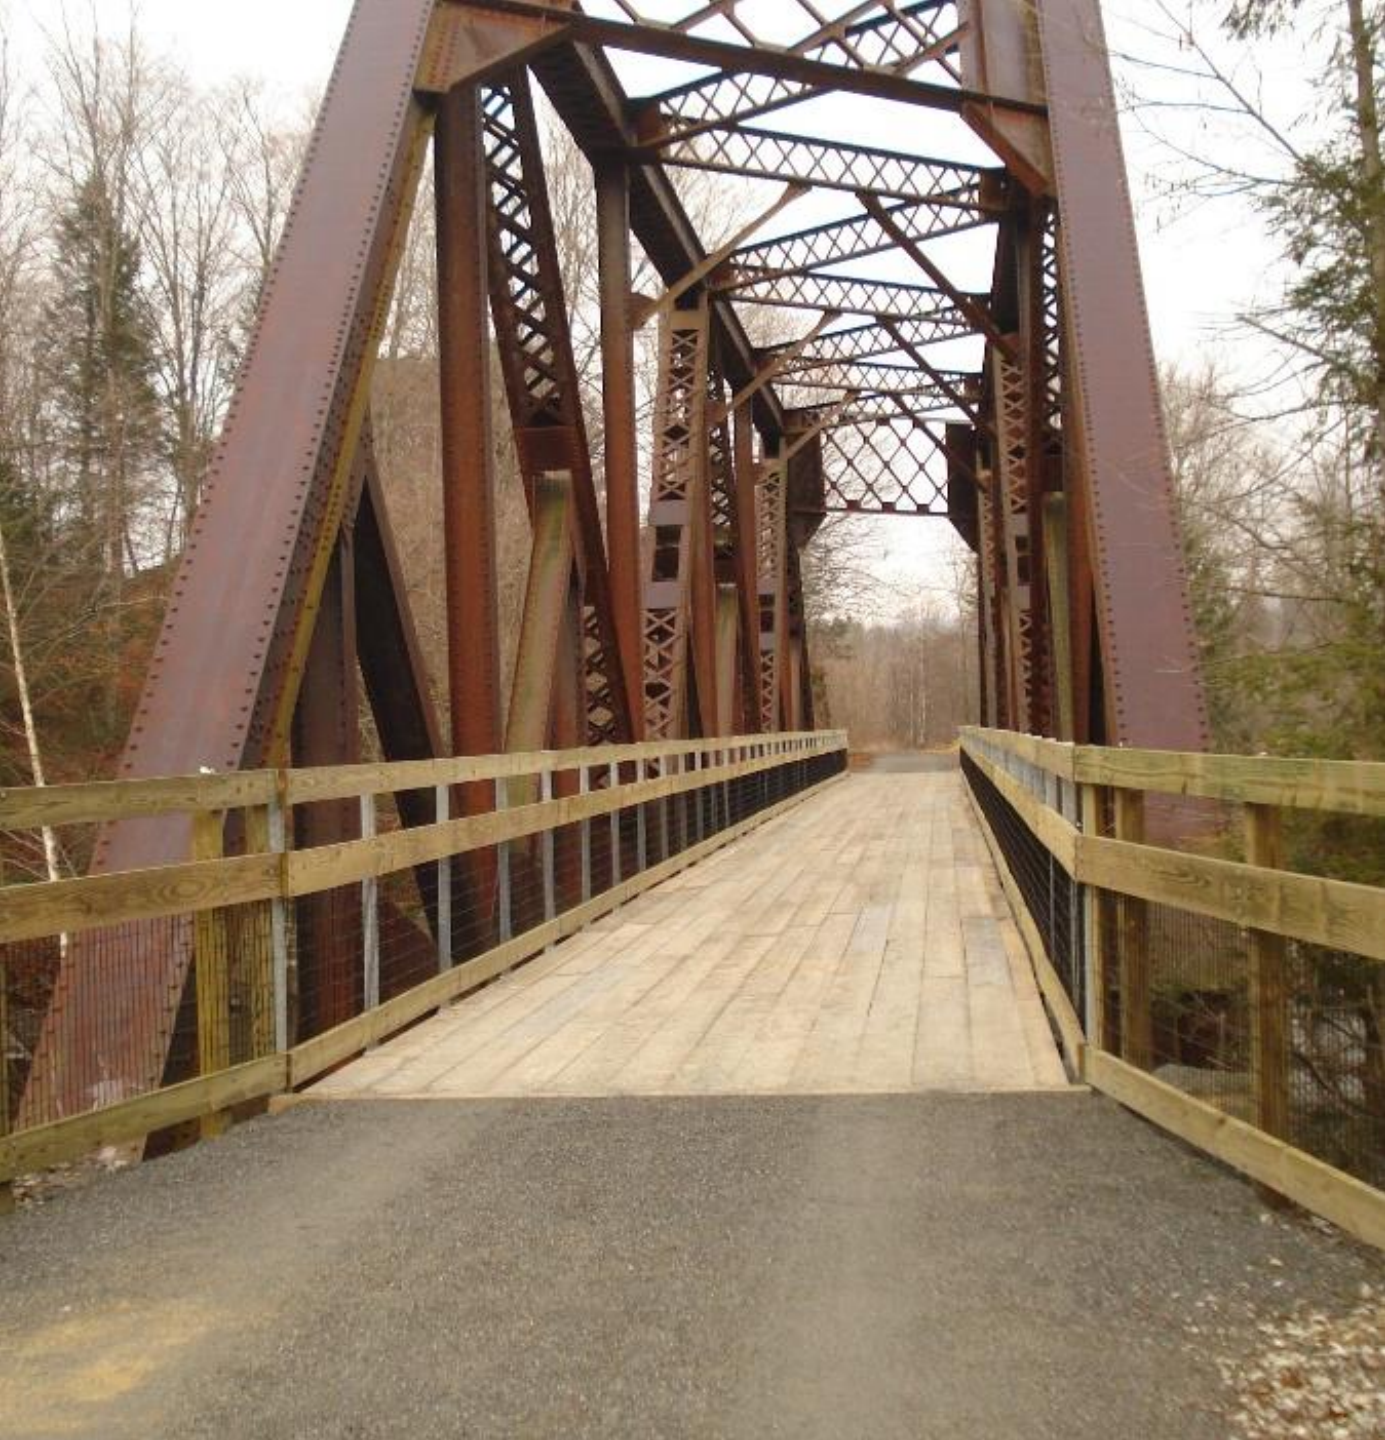
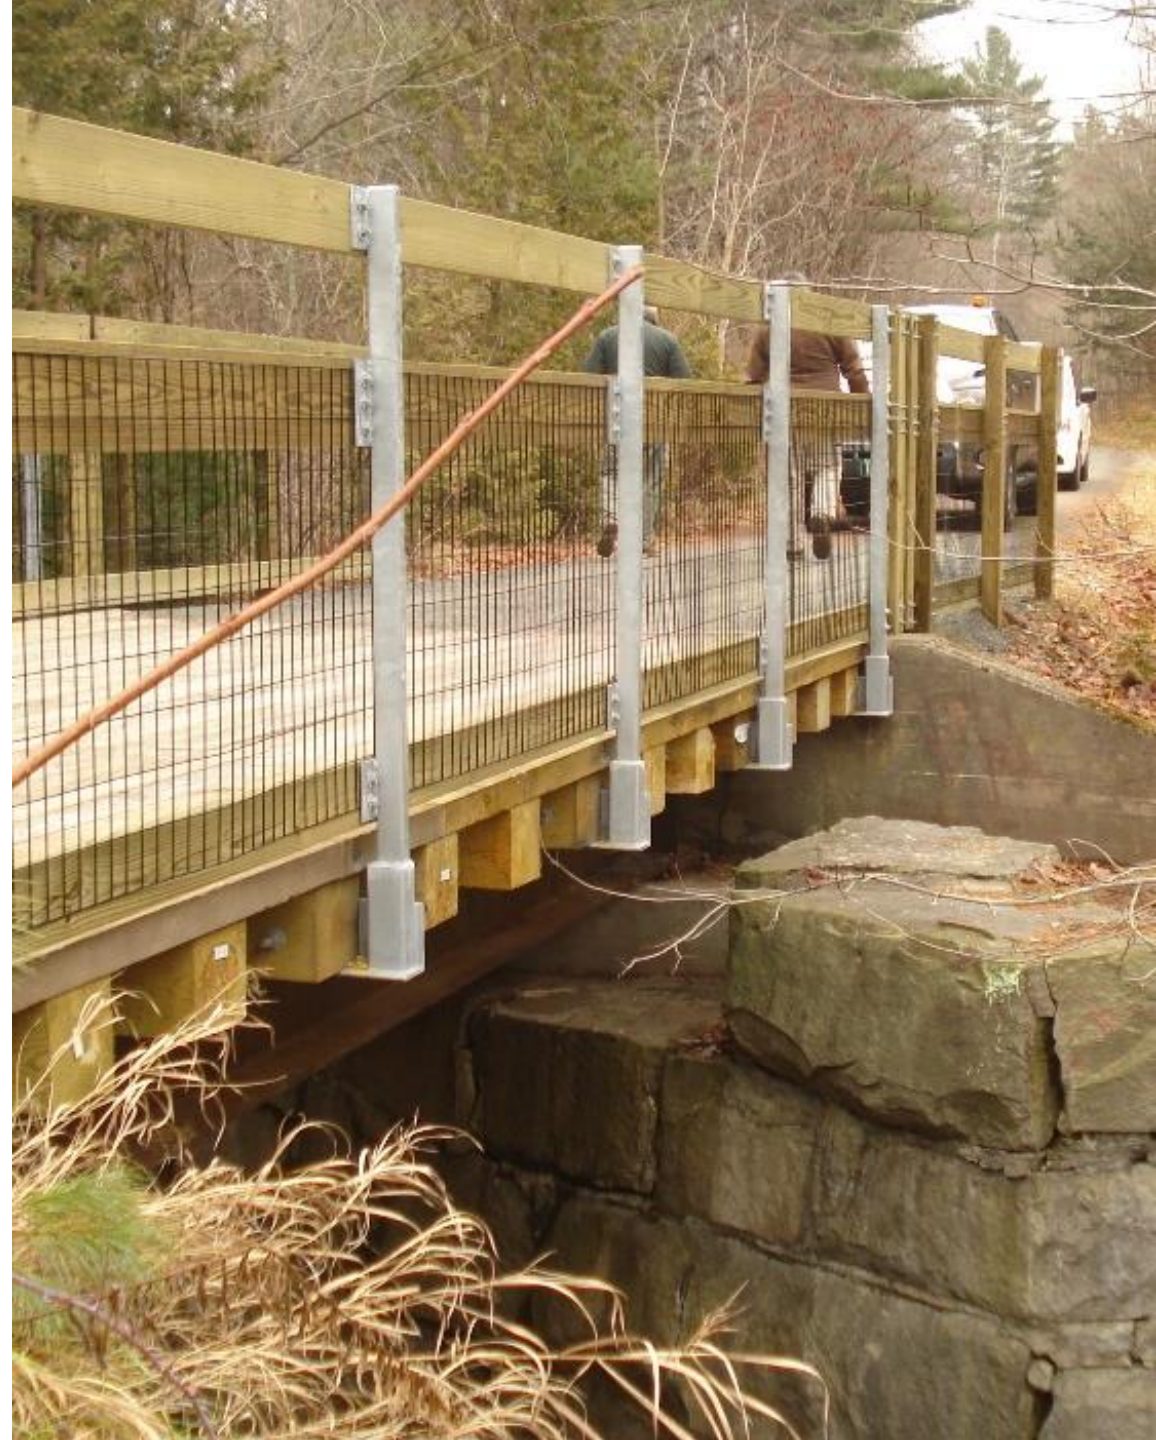
Design Phase

- Use of pre-fabricated trusses
- Deck replacements
 - Railing installations
- Substructures repairs
 - Repair of concrete
 - Re-pointing mortared joints
 - Re-setting stones

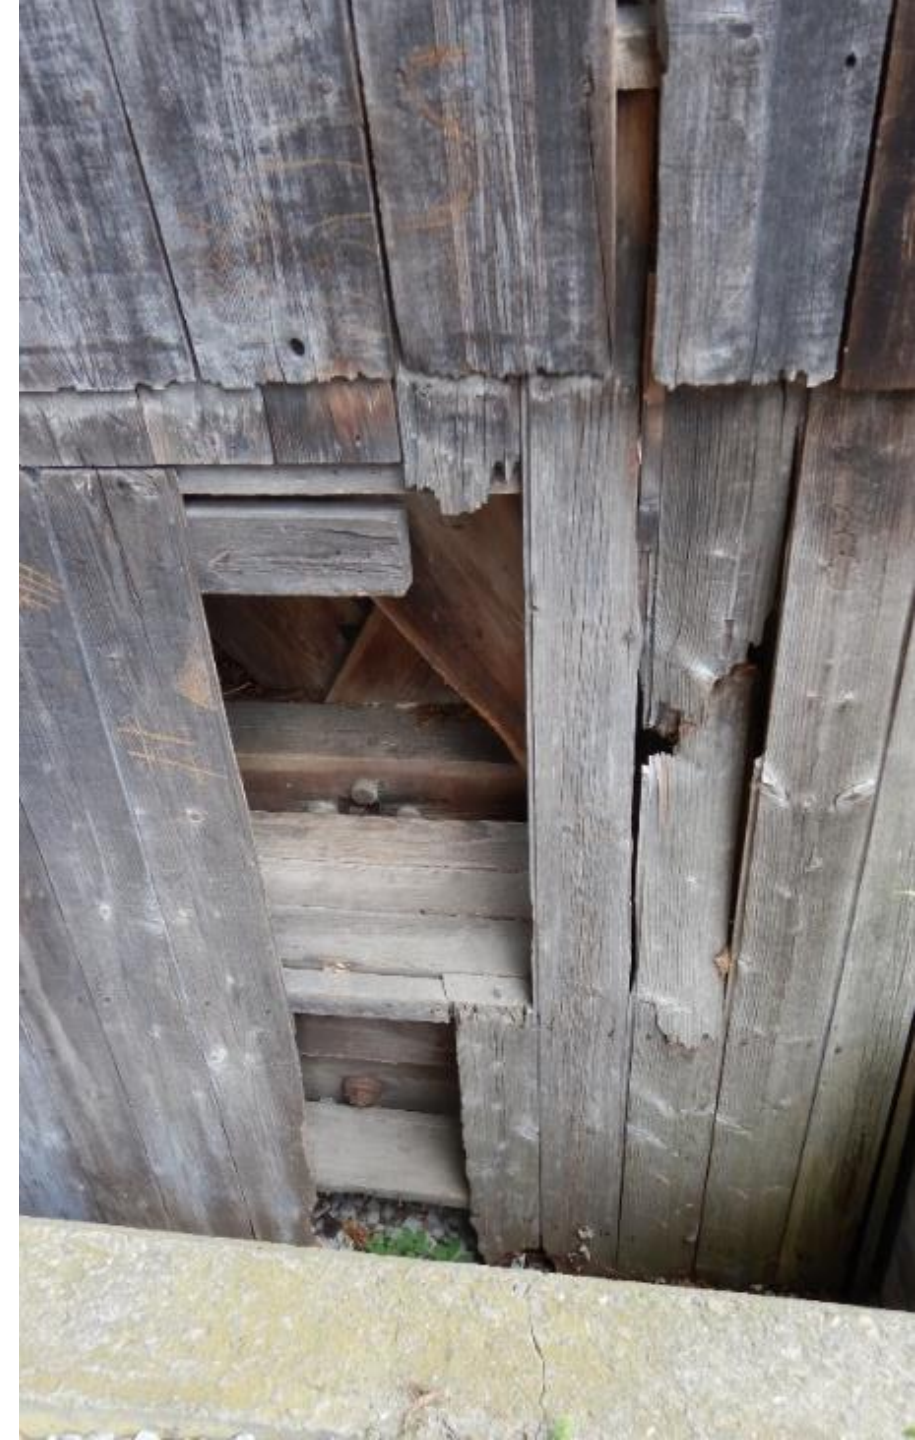
Fisher Covered Bridge

- Minor repairs to the covered truss
 - Remove and replace damaged siding
 - Replace missing trunnel
 - Fire retardant to be applied
- Preserve historic rails

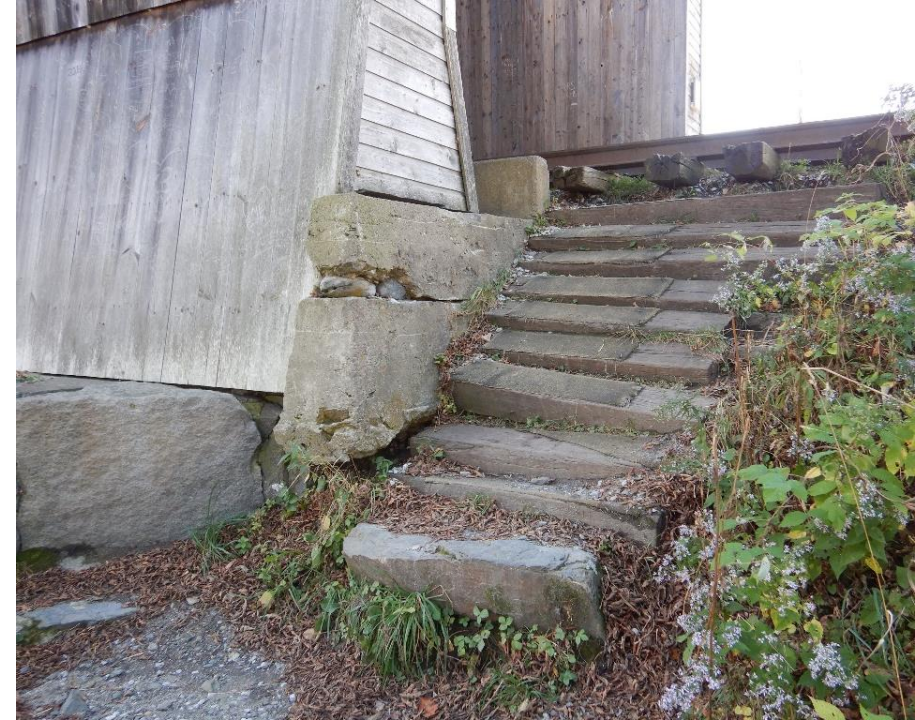
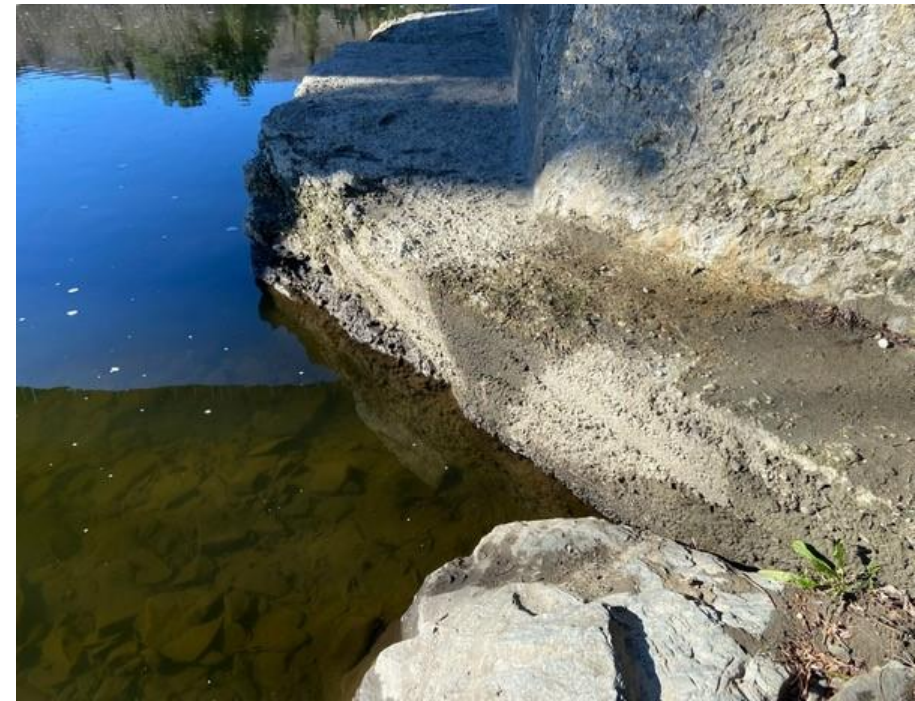
Fisher Covered Bridge

- Rehab abutments
- Concrete repairs
- Repointing of masonry
- Replace bridge seats and backwalls

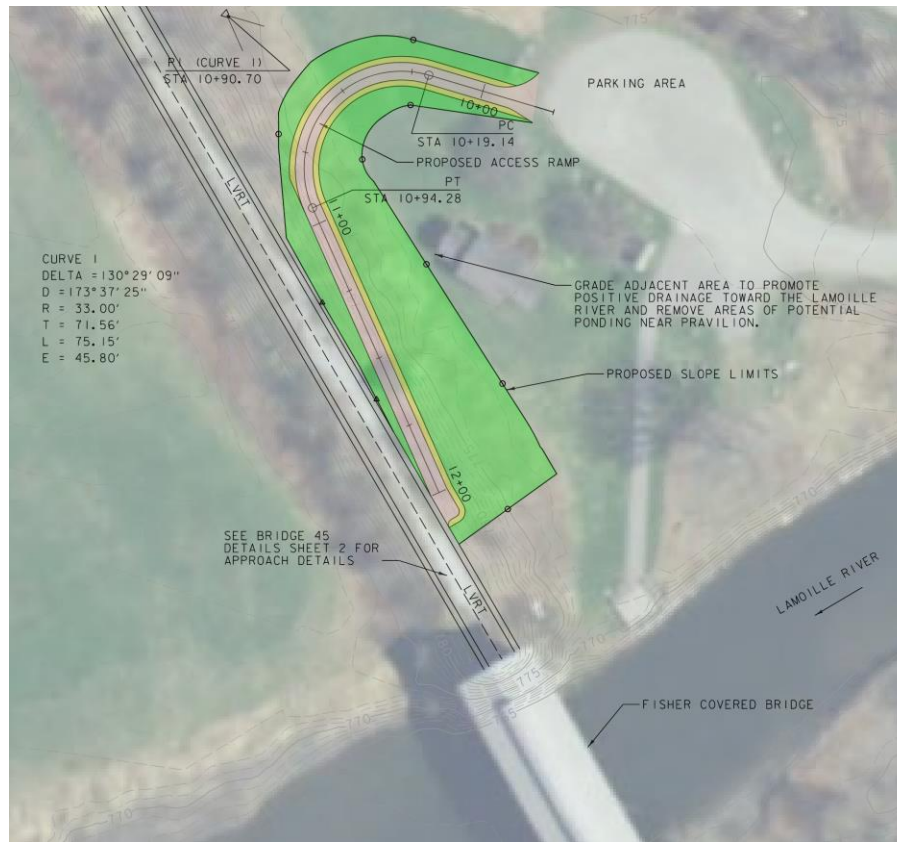
Fisher Covered Bridge

- Installation of access ramp
- Informational panels
